PAINTING CONDITION REPORT

Object: Franz von Stuck Painting
Dirk Soulis Auctions
Lonejack, MO

Examining Conservator: Rick Parker

Date of Examination: 9/15/22

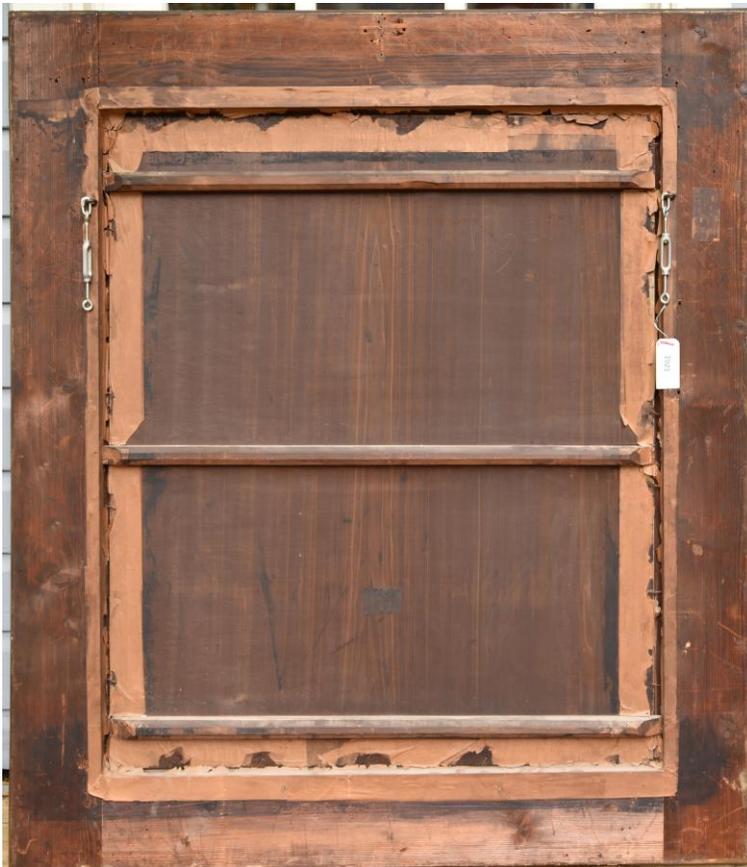
Structure: The painting is on a softwood (unidentified conifer, possibly pine) panel consisting of four panels glued together. The cut of the wood is mostly radial but, in the center, there is clearly a tangential cut making the over-all panel somewhat unstable in that area. In addition, there are three battens running horizontally glued to the back.

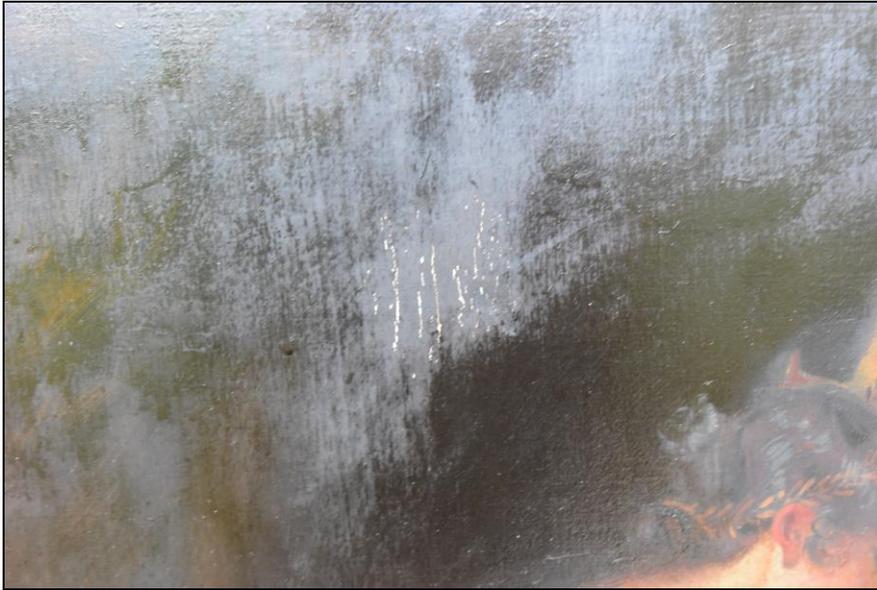
Normally this would indicate some inherent stress and potential cracks in the tangential board. The battens are secure and there are no cracks or insecurities visible on the back of the panel. That said, there are vertical stress cracks through the paint into the gesso on the front of the painting where that tangential board is located. This would also indicate some, as of yet unresolved internal stress related issues on that particular board in the panel.

This particular cracking appears to be recent in that it is through all of the varnish and paint layers to the gesso layer with almost no particulate or dirt and debris in the cracks. By not having any varnish in the cracks it would also indicate that this has evolved since the last varnish was applied. The panel core remains flat and with good environmental conditions should stabilize. Excessive changes in the panel due to environmental shifts could cause further and more excessive cracking.

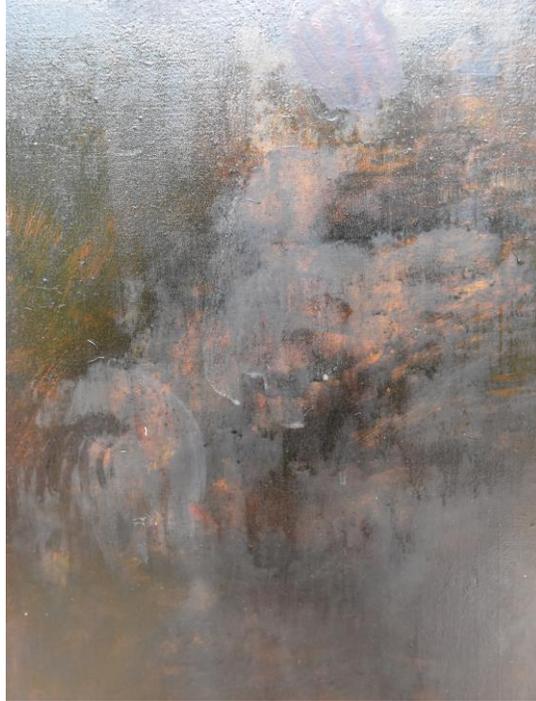
Painting: The painting is of a single figure playing a lyre being shadowed by two demons. The over-all appearance is very dark with irregular varnishes being quite darkened with normal aging and accumulated particulates and oils. There are numerous runs in the varnish as well as broken remains of the brush used to apply the varnish.

The surface is not continuous but very splotchy and irregular. There are clearly multiple layers of varnishes. Under UV at 365 nanometers the surface is clearly much different. There is a thin but very continuous oil resin varnish present with very few breaks of any kind. The runs, drips and spills as well as a less than consistent varnish coating is actually under a more recent oil resin. Given the amount of darkening and particulate UV light penetration is not as thorough as it could be if the layers were less thick and dark. However, the original paint appears intact and very stable. This is clearly a grotto scene with a small pool and water cascade in the lower PR portion of the painting.

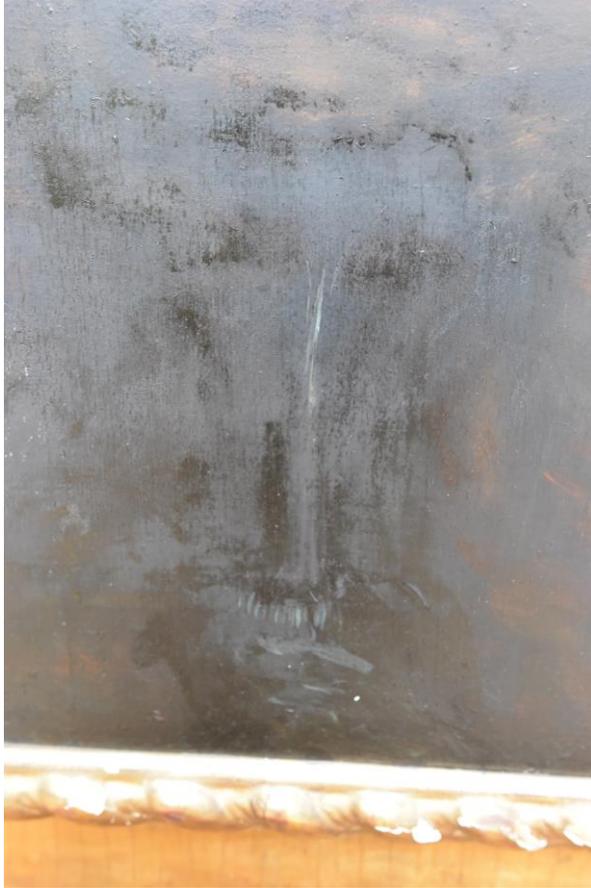
This is almost completely obscured. There is also clearly other painted subject matter that is just hidden by the darkened varnish. The two demons in the upper portion of the painting are greatly obscured by the darkened varnish but the original paint seems intact underneath.

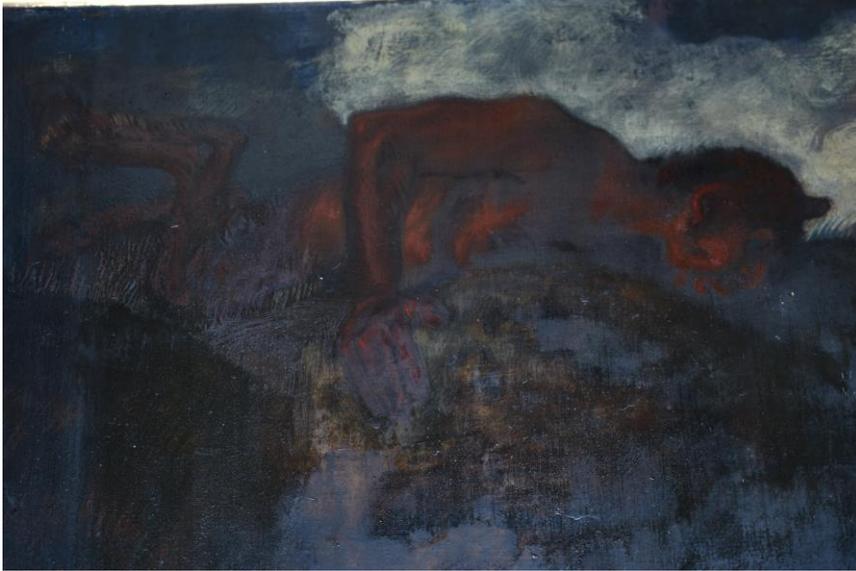
Above the demons is an area of sky with clouds which at first glance could be mistaken for an over paint or something missed by a varnishing. The sky under both long and shortwave UV is just lost in the darkened varnishes to the point of being recognizable but not at all as was intended by the artist. The figure is somewhat more recognizable with a red colored dress. The lyre is also more clear than other portions of the painting with many details visible.

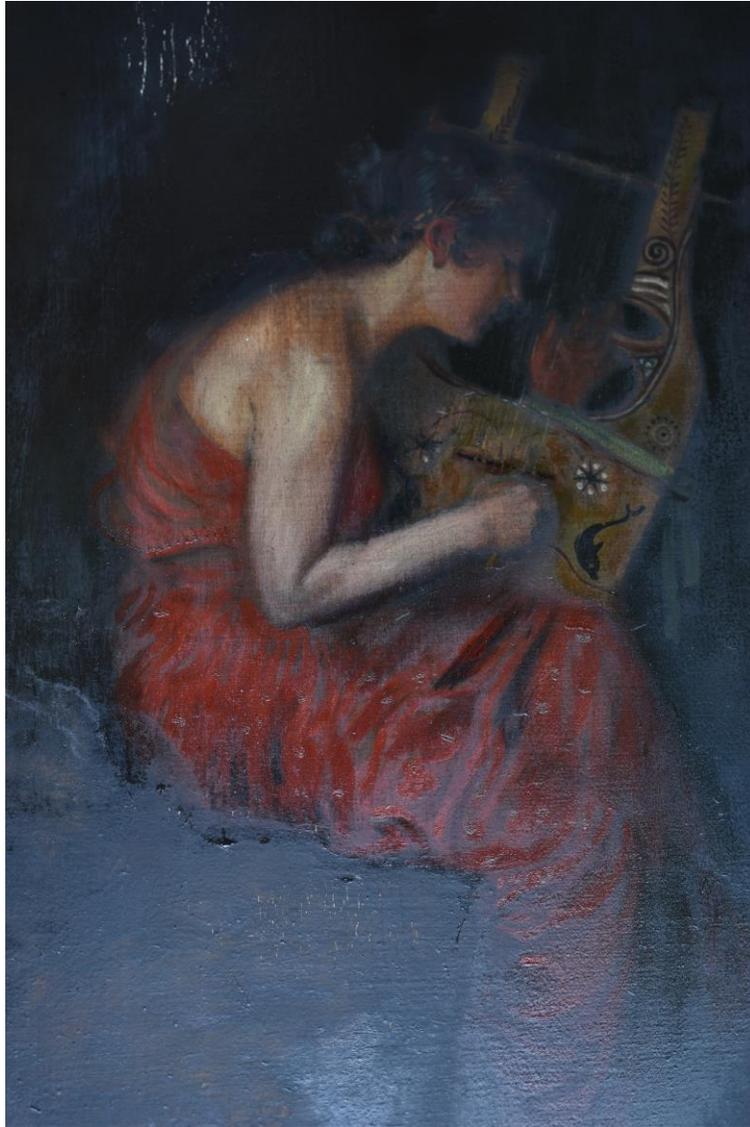
The red dress under long wave UV (365 nanometers) shows the accumulated varnishes but a series of around three dozen very small crosses light up under the UV. When shifting to another wavelength (short wave at 254 nanometers) only the crosses from the knee down are visible indicating different materials. It is felt that these crosses are possibly gilding meant to represent details on the dress and not a later damage or addition. In addition to the crosses there is a fringe that is visible in the waist area. The figure's shoulder has had a portion of the varnishes and debris either abraded or worn off. It is a more true color but still not as clean as it was originally intended. There are some very dark spots in several places on the painting that could represent some later inpainting and touch up work, but the varnishes are too thick and dark to get a conclusive read on those areas. The signature on the PL lower portion of the painting is clearly below all of the varnishes and shows no indication of any alteration. When looked at under both long and short-wave UV it completely blends with the existing background indicating consistency with the surrounding paint.

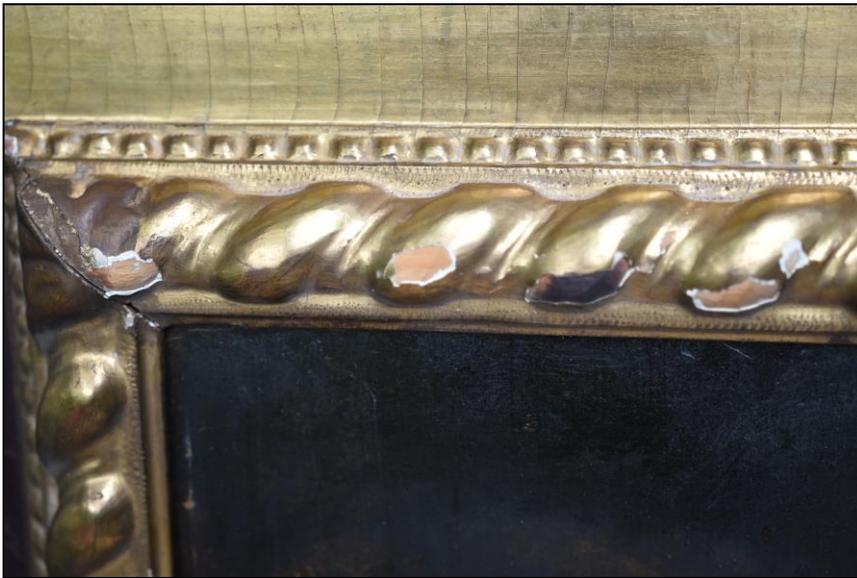
The frame is made of an unidentified softwood that has been gessoed and water and oil gilded. There is a red bole present under the gilding. There are three locations of missing pieces on the top horizontal portion of the frame and approximately 16 areas of loss on the horizontal lower portion of the frame. The spiral carving on all four sides shows considerable wear and some loss but is acceptable when age and usage is factored in.

There is considerable dirt and particulate but no real additional damage from added coatings. The exception being all four corners where an oil resin has been applied at some earlier time and darkened with age. Further microscopic examination needs to determine exactly what the function of those four corner colorants were. There are two very dense hardwood panels running vertically on the sides of the painting.

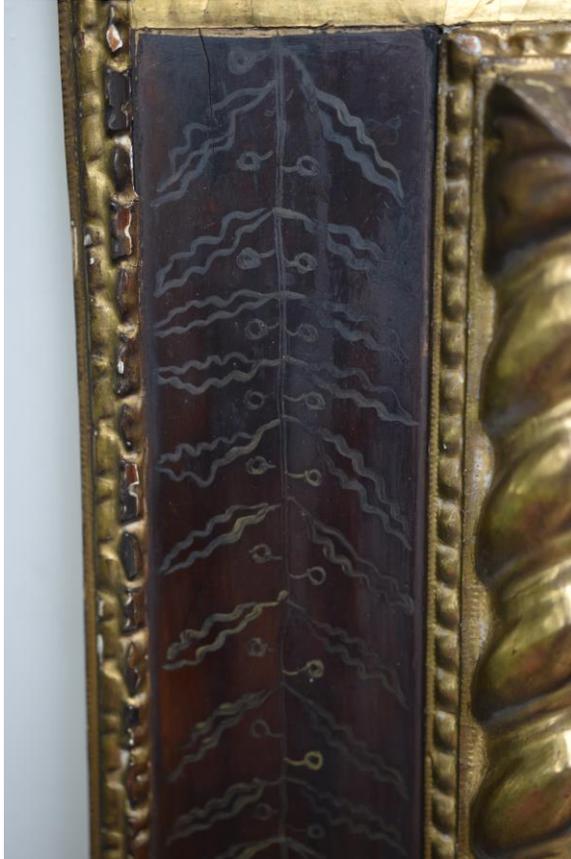
While dark, both have fairly good visibility and not as much darkening as is found on the actual paint. Both wood panels have a floral motif running from top to bottom that is painted on. These elements are more sensitive to particulate and have darkened more visibly than the wood they are painted on. The corresponding top and bottom horizontal flat panels are gilded and have structural cracking indicating some environmental expansion and contraction. These currently appear stable.
